Manhole Inspection Summary

Manhole # S21CC_035MH

Insp Date: **10/22/07 1:27 PM**

Location Address: **1112 ALLEY-MCKEAN-FULTON**

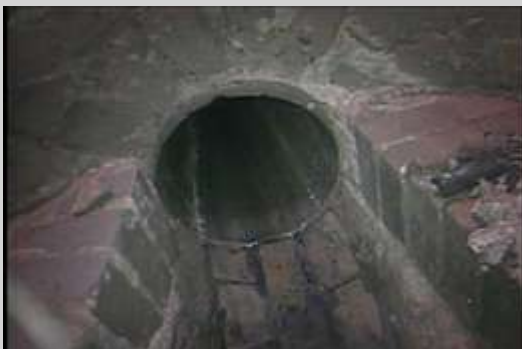
3 O'Clock Inflow

8 in. Circular Gravity Sewer
Pipe In @ 3 O'Clock

Pipe Height: **7.2** (in.) Rod and Bar (Angled)
Pipe Material: **Clay** ☐ Pipe Lined
Invert Depth: **8.48** (ft.) Flow Characteristics: **Slow**
Deposits: ☒ None ☐ **Mud** ☐ Sludge ☐ **Debris** ☐ Grease
Silt Depth: (in.) Deposits Extent:
Infiltration: **None** Pipe Seal Cond: **Sound**
